December 1, 2006

**RE: Soil Characterization (Lead & Arsenic)  
Former Zieger Rose Nursery Property  
1760 & 1756 Dreshertown Road, Dresher 19025  
Upper Moreland Township, Montgomery County, PA  
TPN: 54-00-054-100-08  
DelVal Job # 05-611A**

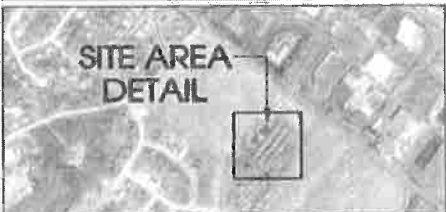
SITE AREA  
DETAIL

The exceedance areas depicted in this diagram are based on the interpolation of lead and/or arsenic concentrations which were identified at discrete locations. Actual concentrations at other locations may differ from interpolated values represented in the model. For further details see accompanying report.
